**OSHA FALL PROTECTION TEST REPORT**

**AMERICAN SKYLIGHTS**

**PRODUCT TYPE: Fall Protection Screen for Fixed Skylight**

**Report No: A7803.01-801-44**  
**Test Date: 02/17/11**  
**Report Date: 02/18/11**  
**Expiration Date: 02/17/15**

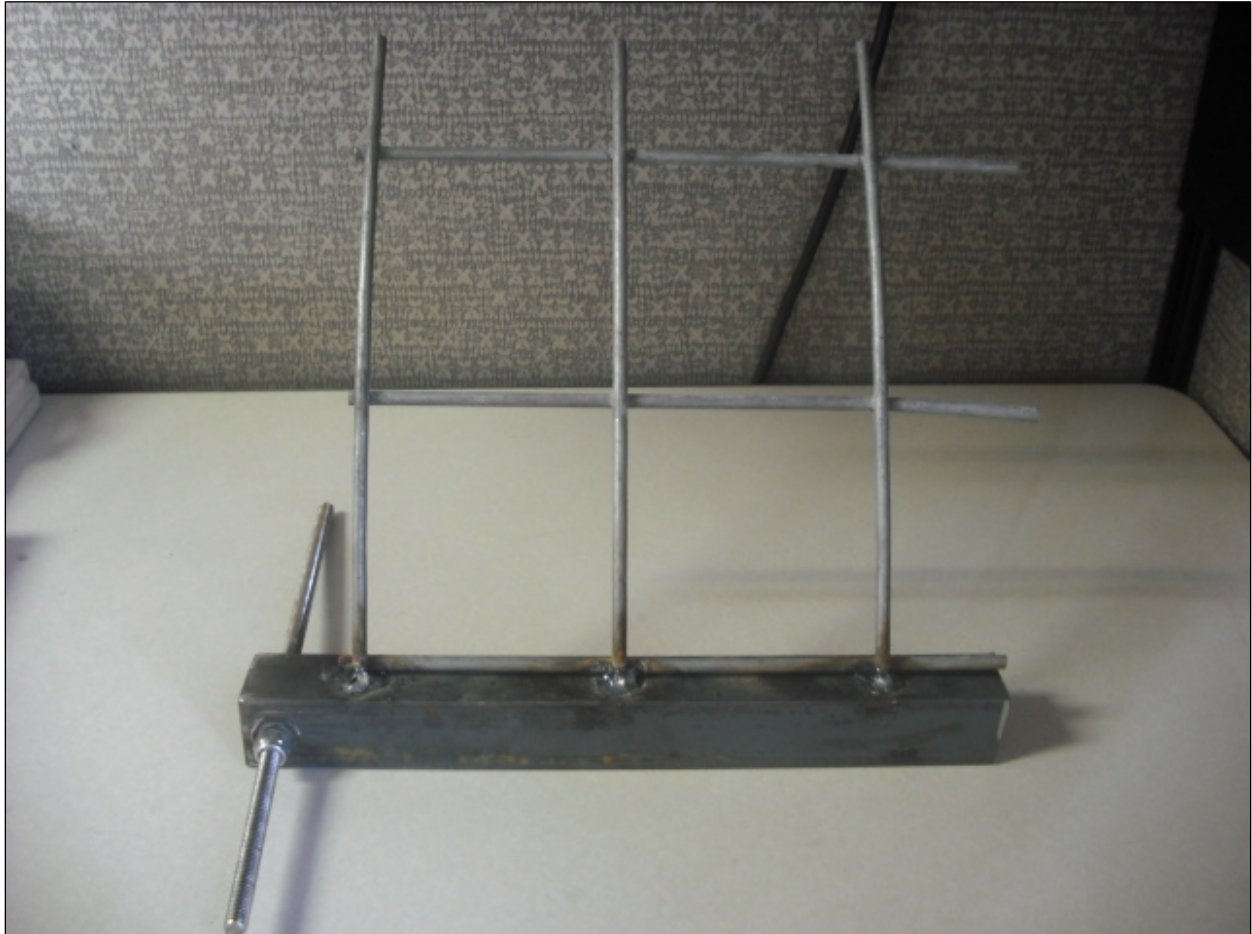
**Photo #1: Screen sample**

**Screen Construction:** The screen was comprised of 3/16" diameter steel rods welded into a 4" on center perpendicular grid pattern. The screen was welded at rod ends to a piece of 1-1/4" x 1-1/4" L-shaped steel along each end.

**Installation:** The screen was fitted over a 2x6 SPF curbing. Each end was tightened together with a 96" piece of all-thread attached with a 1/2" lock nut at each of the L-shaped steel pieces.
